Case Report

Revision of a Fractured Uncemented Revision Stem Using a Custom Designed Punch and Retrograde Through-Knee Approach

P. J. Nasr and G. S. Keene

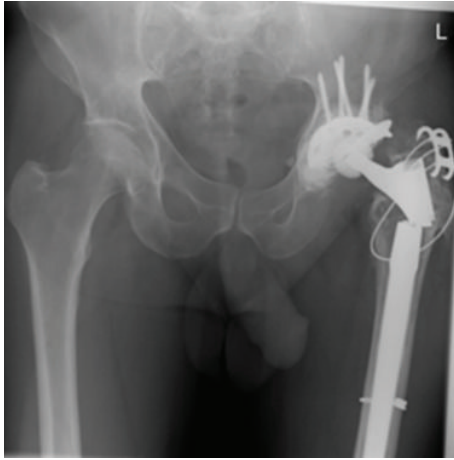
FIGURE 1: Plain AP pelvic radiograph of broken Revitan stem.

Four years later, the patient presented with pain in his left hip and some weakness. Clinical examination revealed new shortening of his leg associated with pain on attempted straight leg raising. His BMI was unchanged. Radiographic examination showed a fracture around the Revitan connection taper, which was confirmed following explant of the prosthesis (Figure 1). There was no evidence of infection.

A decision was made to revise the prosthesis and a unique operative plan to retrieve the distal part of the broken femoral stem using a custom made instrument inserted via the knee in a retrograde fashion, rather than split the femur to retrieve the prosthesis and then use a longer stem. The 14 mm diameter instrument was manufactured by the surgical devices unit at our University Hospital, as a 500×14 mm long straight punch, with the end shaped in a concave fashion to engage the tip of the femoral stem.

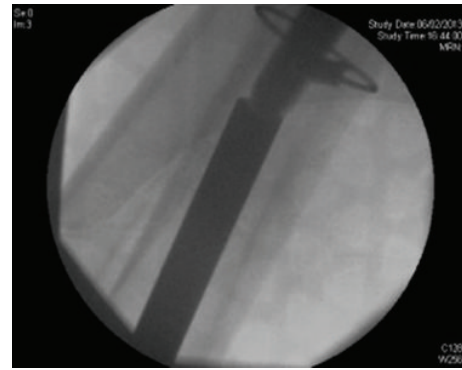
FIGURE 2: Intraoperative image, intensifier image of custom made instrument contacting tip of Revitan femoral component.

A posterior approach was used to the hip. The stem could not be retrieved from the area around the greater trochanter. Attention was then made to retrieval of the well fixed diaphyseal portion of the broken stem. A midline incision was made over the knee and a medial parapatellar approach performed. A 16 mm drill was used to gain entry to the distal femoral metaphysis and our custom made instrument inserted retrograde to punch the well fixed femoral component towards the proximal femur. Image intensifier guidance was used throughout the procedure (Figure 2). The stem was disengaged and then retrieved with ease, without any fracture occurring or loss of the femoral bone stock (Figure 3).

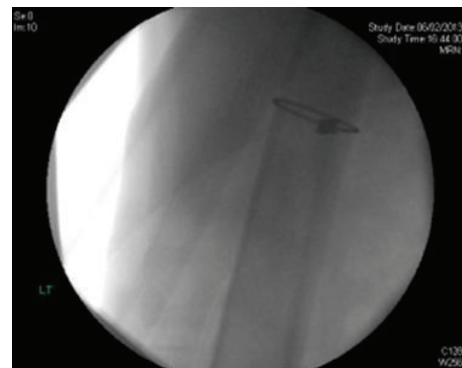
FIGURE 3: Intraoperative Image Intensifier image of femoral diaphysis after removal of Revitan femoral component, showing no evidence of fracture or loss of bone stock.

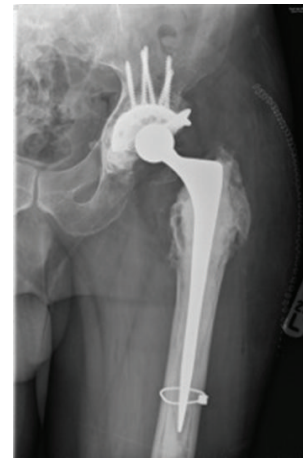
FIGURE 4: Postoperative radiograph of cemented CPT size 4 extended offset stem.

Thereafter, the stem was revised to a cemented CPT size 4 extended offset 200 mm stem (Zimmer, Warsaw, IN) (Figure 4). There were no immediate postoperative complications and the patient was discharged on day 5. Subsequent followup has been unremarkable with no symptoms of knee pain and a well functioning revision hip replacement.

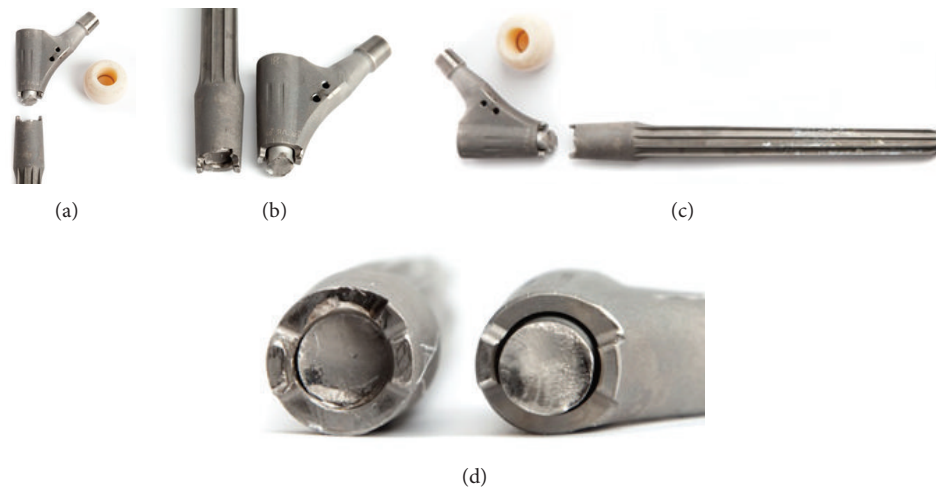
FIGURE 5: Photographs of retrieved Revitan stem.

Analysis of the explanted stem showed that it had fractured at the connection taper (Figure 5).

This study highlights a failure that led to a stress riser forming in an implant that was well fixed distally in the femoral diaphysis. Modular systems do increase the risk of corrosion at the taper [6, 7]. The design of the Revitan taper is

such that it is designed to have the maximal stress of the bending forces concentrated on a section with the smallest diameter to decrease the risk of wear debris being caused by contact between the proximal and distal components. We postulate that the cause of this failure was in part due to the large stresses being concentrated on such a narrow taper.
